Photo Attachments

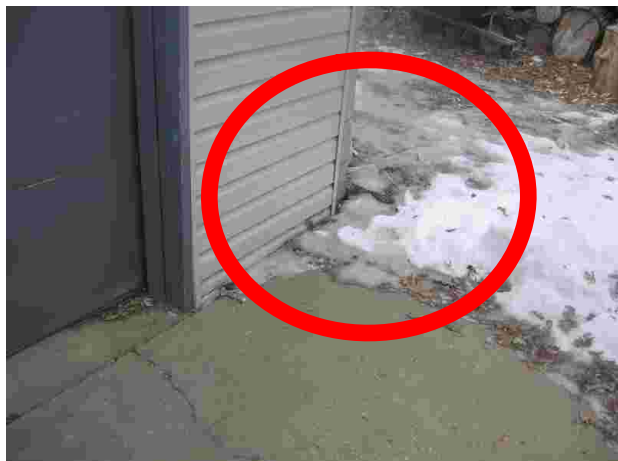
Poor drainage/low lying area at the corner of this garage.

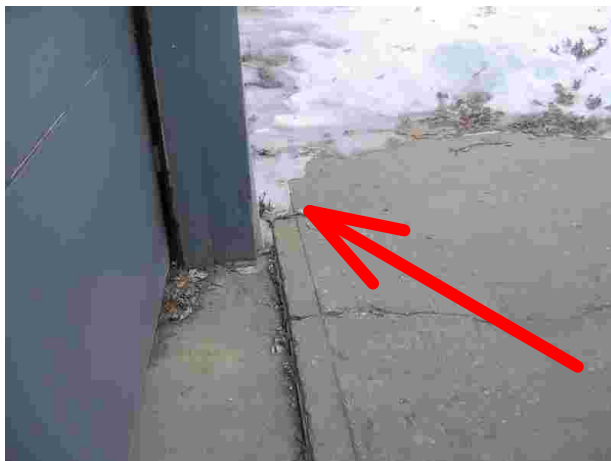
Ice showing the path of the drainage and point of entry under the driveway.

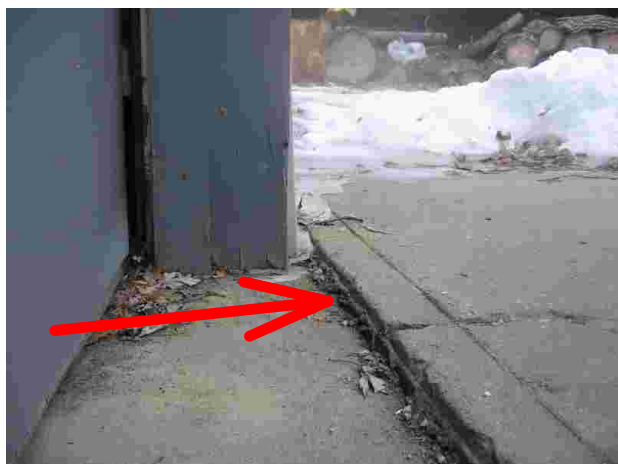
This driveway has heaved 1/2 an inch this winter due to poor drainage.
